U. S. Department
of Transportation
**Maritime
Administration**

Port Damage Assessment

Short-term Action Report—April 2000

**Honduras: Assessment of Port Infrastructure
Damage Caused by Hurricane Mitch, 1998**

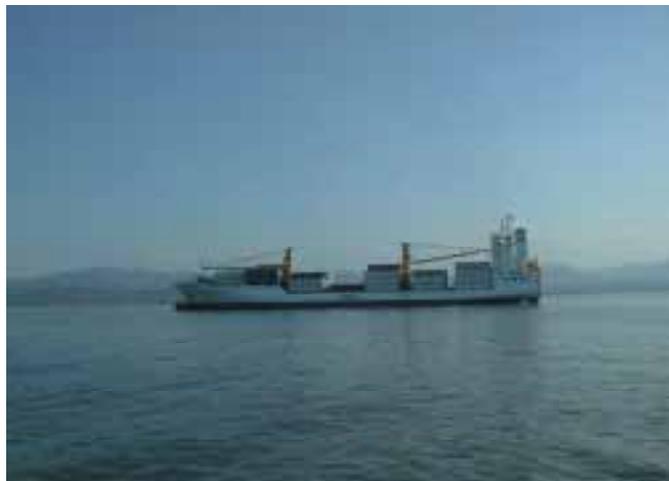
Photo 2. Typical Vessel in Puerto Cortés

draft any of the vessels that have visited Puerto Cortés. Photo 2 shows the typical vessel that arrives into Puerto Cortés.

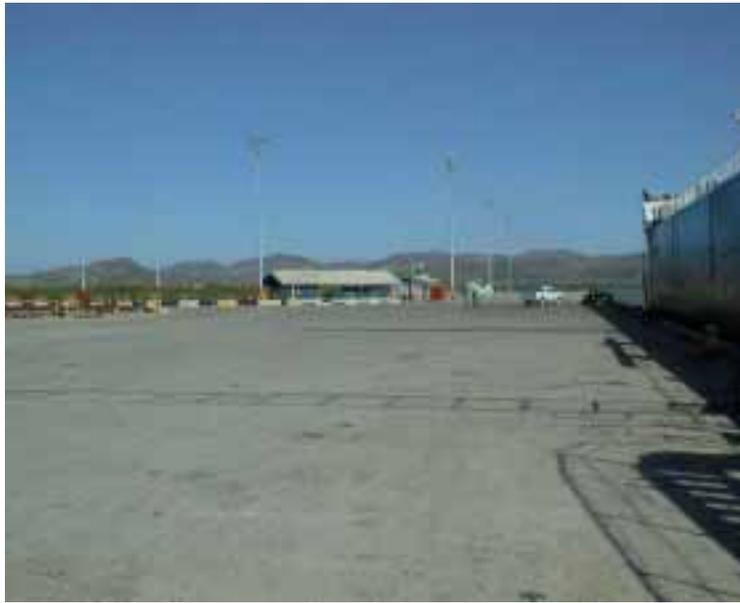
(Photo 3. T-pier, San Lorenzo)

The Port of San Lorenzo is located on the pacific coast of Honduras within the coastal shores of the Gulf of Fonseca in position 13° 24' N., 87° 25.5' W (World Port Index No. 15570). The main pier, which provides four berths, is T-shaped and is 296m long and has a depth of 8.9 to 10m alongside (See Photo 3). Vessels of up to 176m in length, 32m beam, and 7.1m draft can be accommodated.

The Gulf of Fonseca is a large bay that shares its borders with El Salvador to the west, Honduras to the northeast and Nicaragua to the southeast. The entrance to the bay is approximately 14nm wide and has an average depth of 30m. The surrounding coastal features and prominent small islands in the bay provide excellent radar return and visual references necessary to determine ones position. Located on the northeast side of the bay is the beginning of a 16nm approach channel to the Port of San Lorenzo, marked with thirteen lighted navigational buoys (listed below) and 17 unlit smaller can buoys. The approach channel entrance also indicates the commencement of a 9m-depth curve. Port Authority officials stated that most of the navigational buoys were dragged off station during Hurricane Mitch; however, all the buoys were placed back on station.
